Manhole Inspection Summary

Manhole # S09AA1002MH

Insp Date: **8/2/07 11:30 AM**

Location Address: **3324 SEQUOIA AVE**

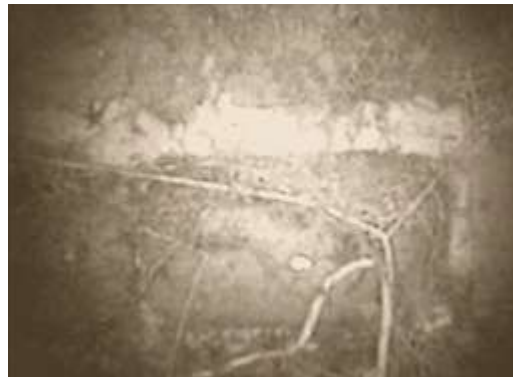
Defect 1

Condition: ☐ Sound ☐ Cracked ☒ **Root Intrusion** ☐ Loose Brick ☐ Deteriorated

Infiltration: ☐ None ☐ Joint ☐ Cracks ☐ Mortar ☒ **Roots** ☐ Wall

ROOT INTRUSION AND INFILTRATION-BARREL

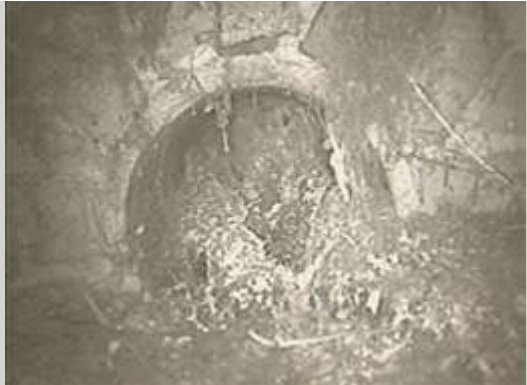
12 O'Clock Outflow

8 in. Circular Gravity Sewer
Pipe Out @ 12 O'Clock

Deposits: ☐ None ☐ Mud ☐ Sludge ☒ **Debris** ☐ Grease

Silt Depth: **5** (in.) Deposits Extent: **Heavy**
